# Inspection Report

123 Main Street

Any MO

**Total Home Analysis**

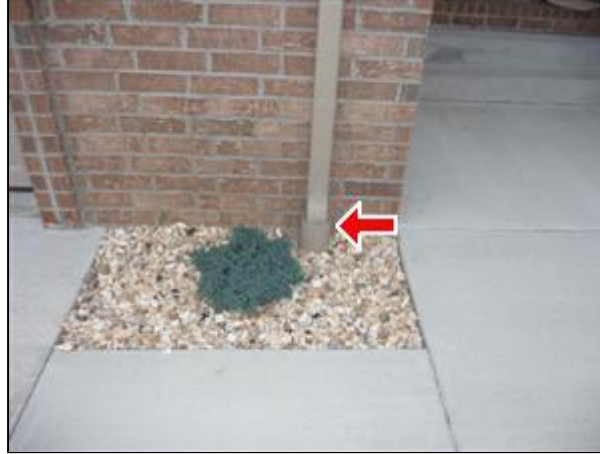
1.3 Picture 1

**1.3** The downspout near the garage was buried and I am unable to determine if drain will function properly.

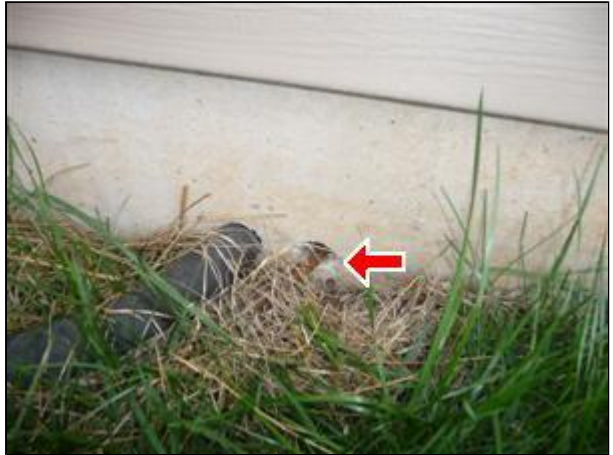
2.0 Picture 1

**2.0** The hole in foundation needs caulking with sealant or liquid foam at the left side (facing front) where compressor lines enter the home.

The hole in foundation needs caulking with sealant or liquid foam at the left side (facing front) where compressor lines enter the home.

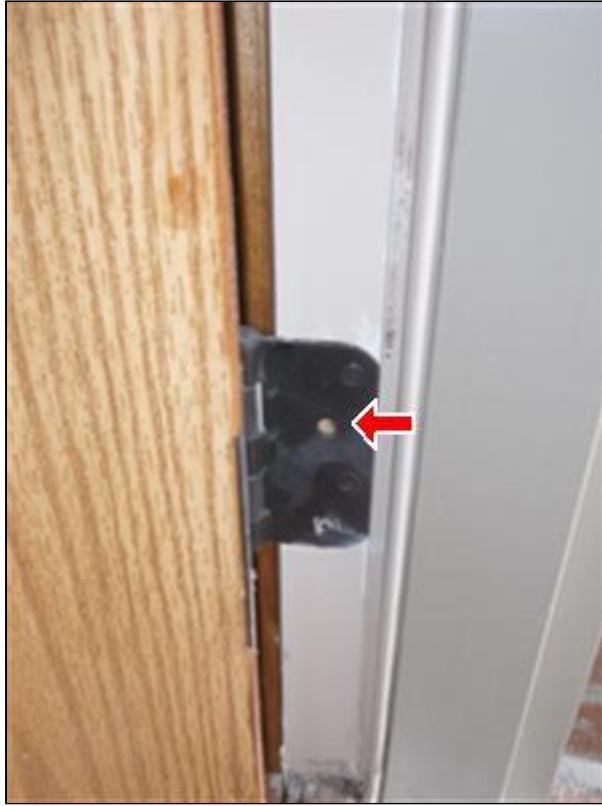
2.2 Picture 1

**2.2** The main entry door missing steel security screw at bottom hinge. This is cosmetic and for your information. A qualified person should repair or replace as needed.

The main entry door missing steel security screw at bottom hinge. This is cosmetic and for your information. A qualified person should repair or replace as needed.

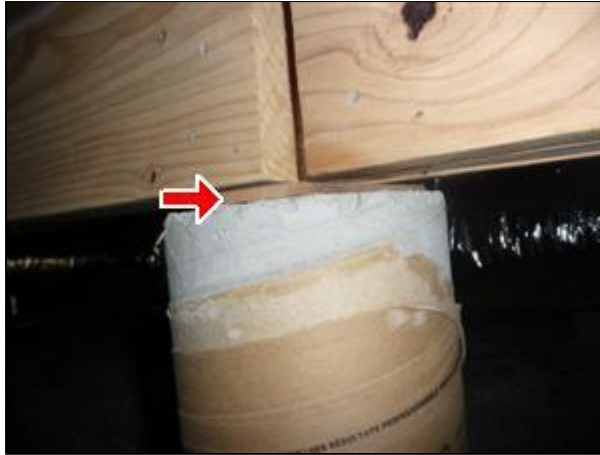
3.2 Picture 1

**3.2 (1)** The support post does not sit on a proper concrete footing in the crawlspace. This area could use reinforcement. A qualified licensed general contractor should inspect further and repair as needed. The column in question is the fourth column from the crawl space door on the center beam.

(1) The support post does not sit on a proper concrete footing in the crawlpace. This area could use reinforcement. A qualified licensed general contractor should inspect further and repair as needed. The column in question is the fourth column from the crawl space door on the center beam.

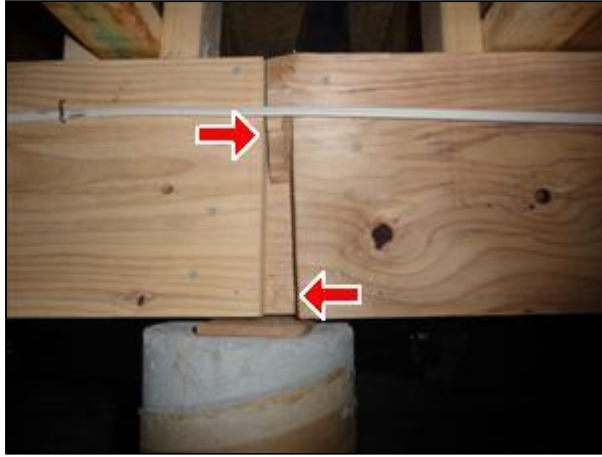
3.2 Picture 2

(2) The wood beam is cut or damaged by tradesman and does not sit on a proper concrete footing in the crawlspace. Repairs are

needed. A qualified licensed general contractor should inspect further and repair as needed. The cut is on the fourth column from the crawl space door on the center beam.

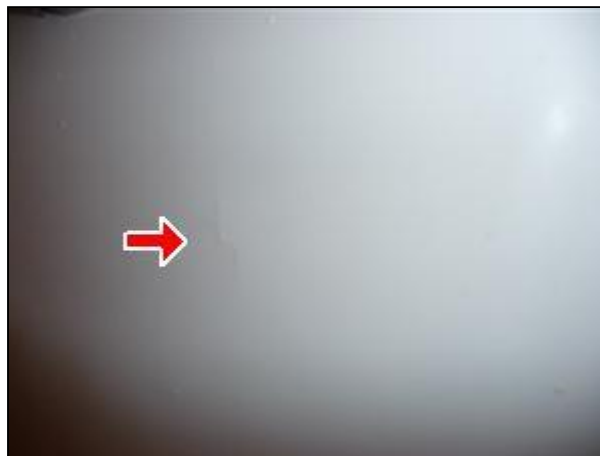
5.2 Picture 1

**5.2 (1)** The shower stall is damaged at the master bath. Repairs are needed A qualified licensed plumber should repair or correct as needed.

(1) The shower stall is damaged at the master bath. Repairs are needed A qualified licensed plumber should repair or correct as needed.

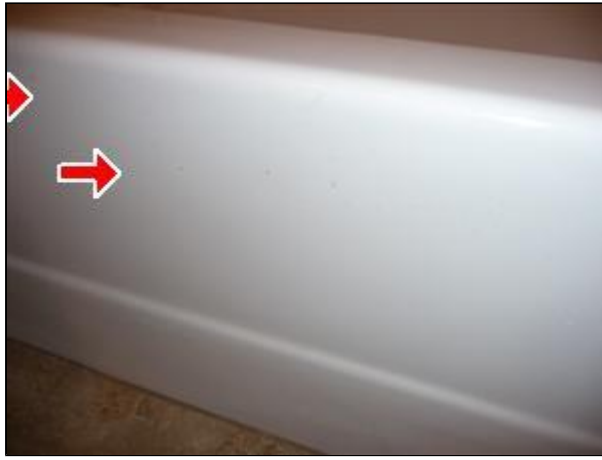
5.2 Picture 2

(2) The bathtub has paint over spray on it at the hall bath. Repairs are needed A qualified person should repair as necessary.

(2) The bathtub has paint over spray on it at the hall bath. Repairs are needed A qualified person should repair as necessary.

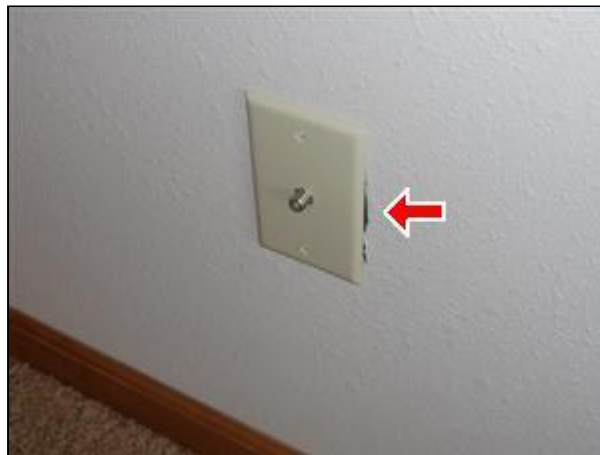
6.3 Picture 1

**6.3** One cable tv receptacle cover does not cover the hole cut for it in the living room. This is for your information. I recommend repair as needed.

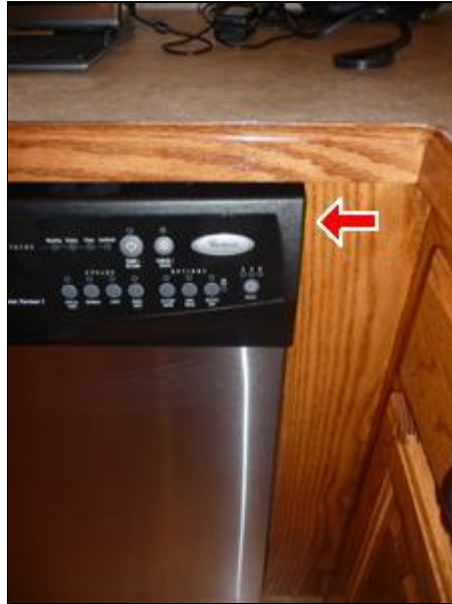
11.0 Picture 1

**11.0** The dishwasher does not close properly and needs adjustment. I recommend repair as necessary.

The dishwasher does not close properly and needs adjustment. I recommend repair as necessary.

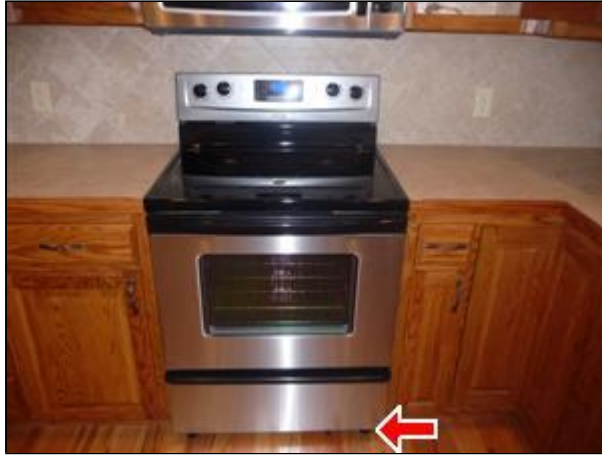
11.2 Picture 1

**11.2** The anti tipping device is not installed. I recommend repair or replace as needed. This device prevents the range/oven from being pulled over by a child.

The anti tipping device is not installed. I recommend repair or replace as needed. This device prevents the range/oven from being pulled over by a child.
